# Old Connaught Phase A1 LRD Quality Audit

Castlethorn Old Conna ULC

0126446DG0023

# OLD CONNAUGHT PHASE A1 LRD

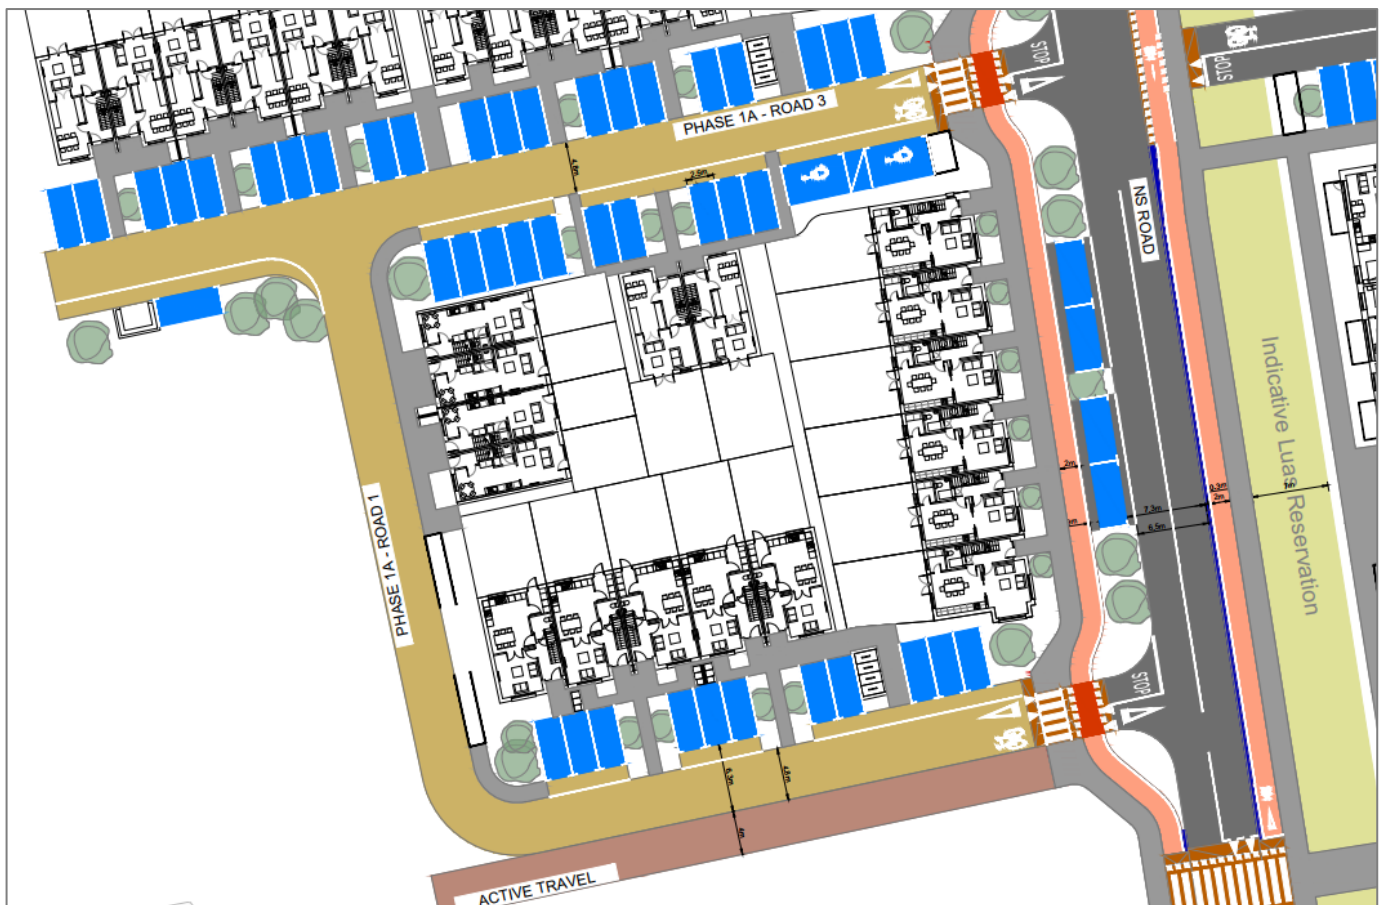
**Figure 2-1 – Lack of Pedestrian Provisions in Western Homezone**

**Location: Western Homezone**

Pedestrians within the Western Homezone are expected to share the full width of the street with motorists. There are currently not sufficient road marking / differentiators to indicate to drivers that they are sharing the road with pedestrians, which could lead to higher driver speeds within homezones. This could lead to pedestrians, especially children, elderly and visually impaired users feeling unsafe whilst utilising the space.

**Recommendation:**

The design team should ensure that the roads within homezones are sufficiently differentiated to indicate that the road surface is shared with pedestrians and that pedestrians have priority within these spaces. Traffic calming measures should also be introduced within these areas.

| To be completed by the Designer | | | | To be completed by the Audit Team |
|---|---|---|---|---|
| 2.1 | Yes | No | <ul style="list-style-type: none"> <li>The carriageway surface within the Home Zone street will be differentiated through the use of contrasting materials, texture, and colour in accordance with Section 4.4.2 of DMURS, thereby distinguishing it from other street typologies.</li> <li>The carriageway width is 4.8 m, which is the minimum recommended width for a Home Zone street as set out in Section 4.4.1 of DMURS. The reduced carriageway width contributes to lower vehicle speeds and improved pedestrian priority.</li> <li>Shared Street Symbol Markings (M133), in accordance with Chapter 7 of the Traffic Signs Manual, will be provided along the Home Zone street. The markings will be installed at the commencement of the Shared Street and repeated after each junction. Where spacing between junctions exceeds 100 m, additional markings will be provided at intervals of 50–100 m.</li> </ul> | Yes |

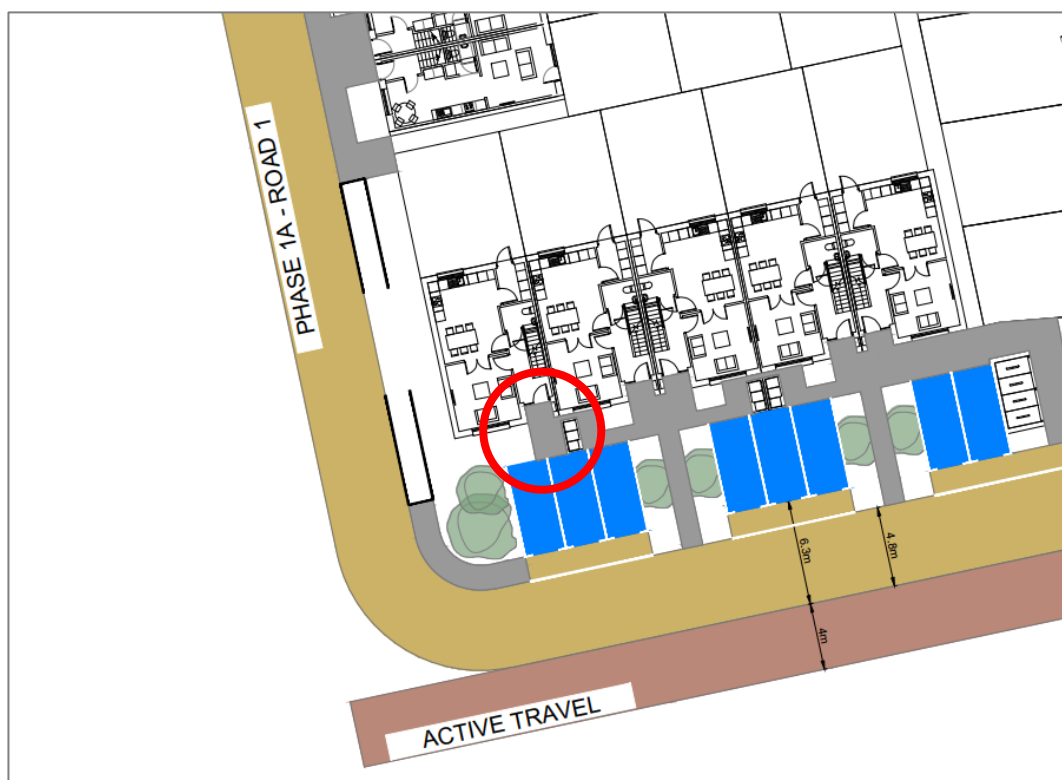
Figure 2-2 – Residence Access in Western Homezone

### Location: Western Homezone

It is unclear how the homeowner in the residence circled below would be able to reach the shared road or pedestrian facility. Access to the shared road is restricted when turning left when exiting the dwelling and turning right when exiting the dwelling necessitates traversing over grassed area to get to the shared road. This might be restrictive to users with wheelchairs or buggies.

### Recommendation:

The design team should provide sufficient access to the shared road and pedestrian facility from the homeowner's front door.

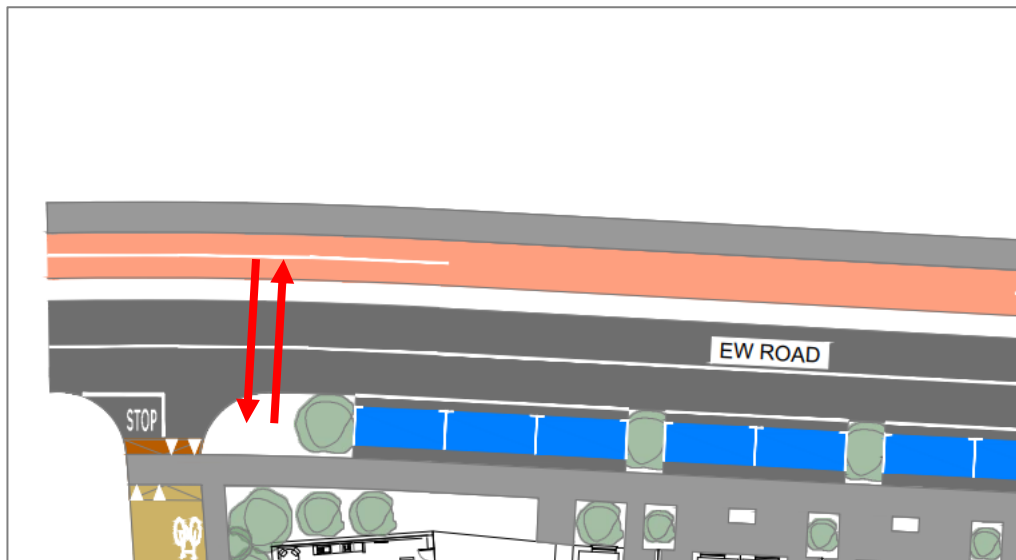
**Figure 2-4 – Future Pedestrian Crossing Provisions**

### Location: EW Road

There may be a future need for pedestrians to cross EW Road. The design does not allow for future implementation of pedestrian crossings along EW Road.

**Recommendation:**

The design team should consider future pedestrian crossing provisions across EW Road.

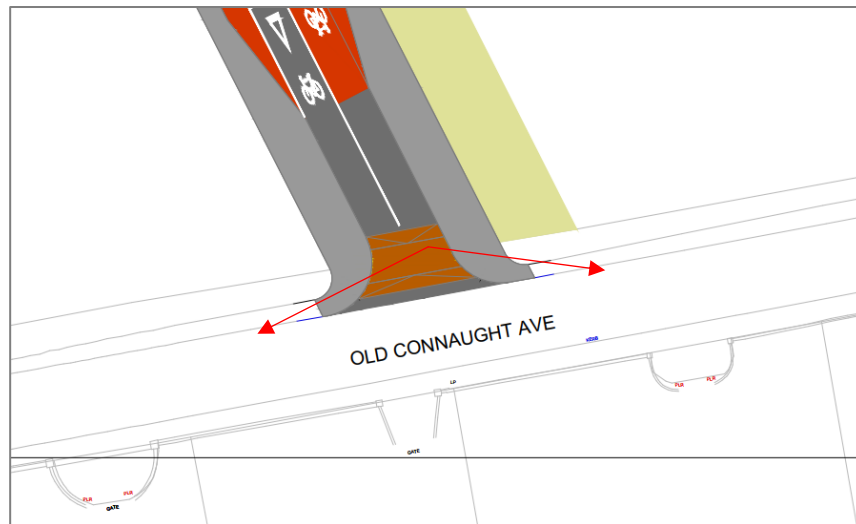
**Figure 2-1 – Sight Lines at Entrance**

**Location:** Entrance at Old Connaught Avenue

It is unclear if there are sufficient sight lines to the left and right of the entrance to the development along Old Connaught Avenue. Restricted visibility splays at the development entrance could result in vehicle collisions due to insufficient visibility provisions for motorists entering and exiting the development junction.

**Recommendation:**

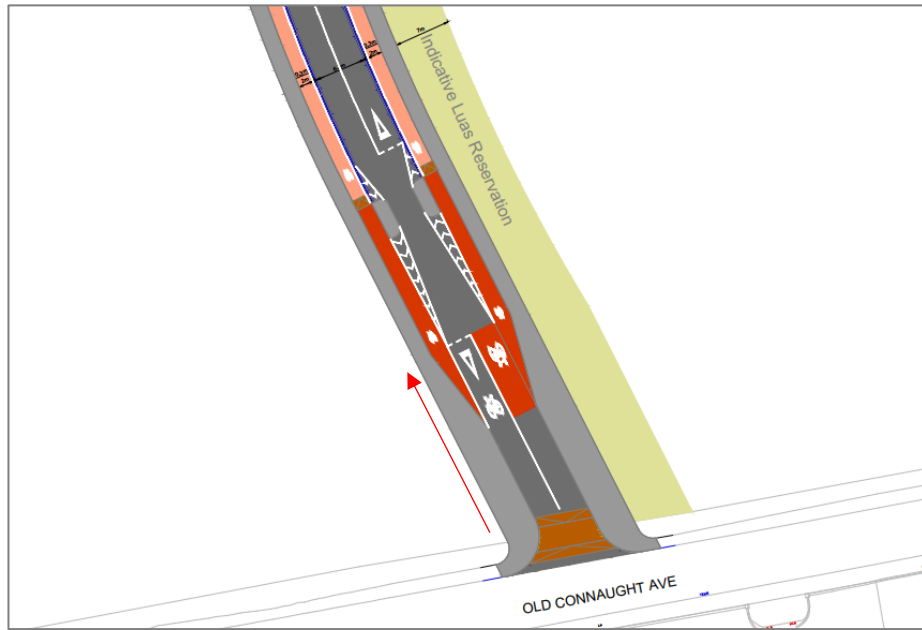
Figure 2-2 – Vehicle Stacking Length at Entrance

### Location: Entrance at Old Connaught Avenue

It is unclear if sufficient stacking distance is provided for vehicles entering the development ahead of the yield markings at the entrance to the development. If the traffic volumes entering the development is high, it might result in vehicles stacking into Old Connaught Avenue, resulting in potential rear-end collisions as a result of vehicles, particularly where there may be visibility issues.

### Recommendation:

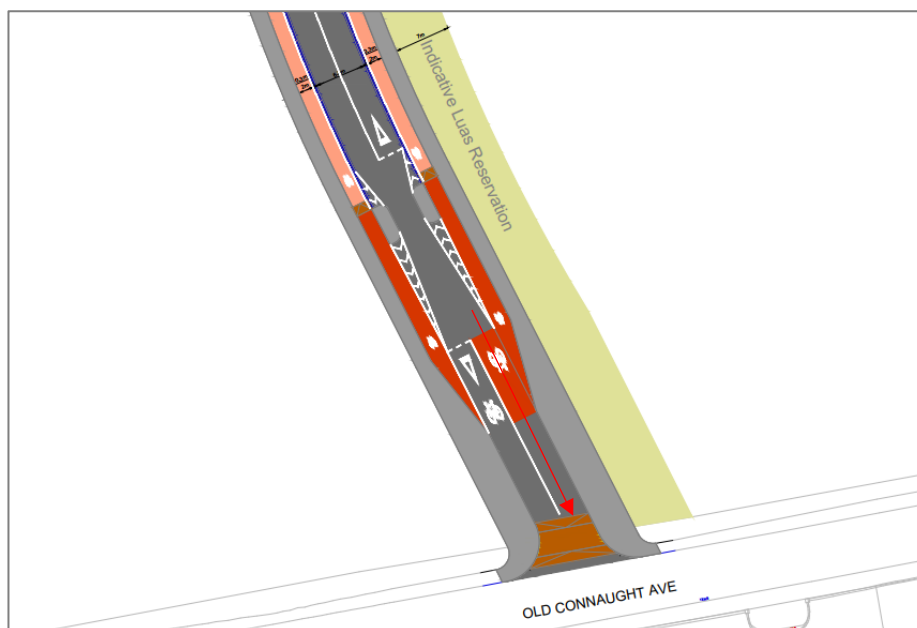
**Figure 2-3 – Vehicle Queue Length at Entrance**

### Location: Entrance at Old Connaught Avenue

It is unclear if sufficient queueing distance is provided for vehicles exiting the development onto Old Connaught Avenue. If the traffic volumes exiting the development is high, it might result in vehicles stacking into the pinch point along NS Road, resulting in potential vehicle conflict.

**Recommendation:**

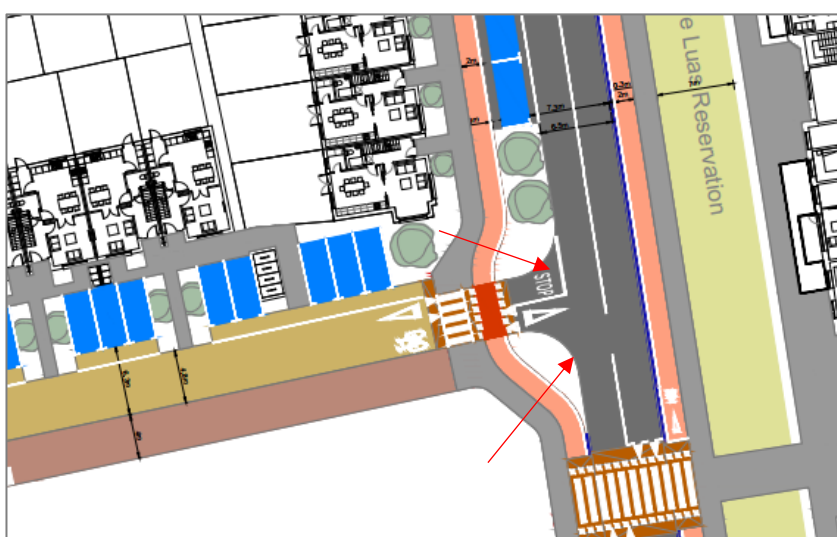
**Figure 2-4 – Large Corner Radii**

**Location: Old Connaught Development Throughout**

The corner radii at junctions within the development appear to be large, which might encourage higher entry/exit speeds along the development roads. This could result in conflict between motorists and pedestrians.

### Recommendation:

| To be completed by the Designer | | | | To be completed by the Audit Team |
|---|---|---|---|---|
| 2.4 | Yes | No | The junctions have been designed with 4.5 m corner radii, which are in accordance with DMURS recommendations for local streets, to provide a low-speed environment while accommodating service, refuse and emergency vehicles. | Yes |

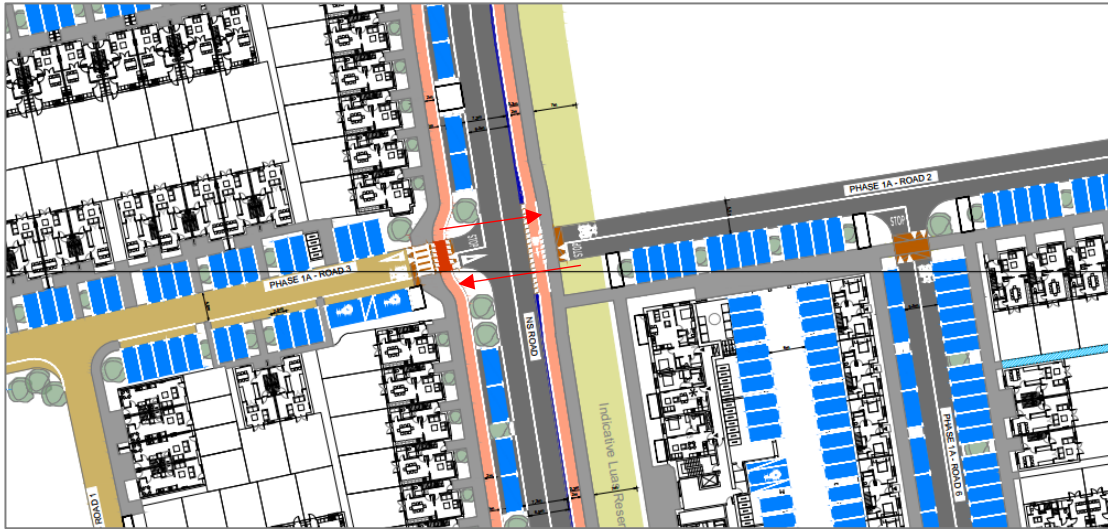
Figure 2-5 – Pedestrian Desire Lines

### Location: Old Connaught Development NS Road

The desire line for pedestrians traveling between Road 2 and Road 3 is currently not catered for, which could result in conflict between pedestrians and vehicles.

### Recommendation:

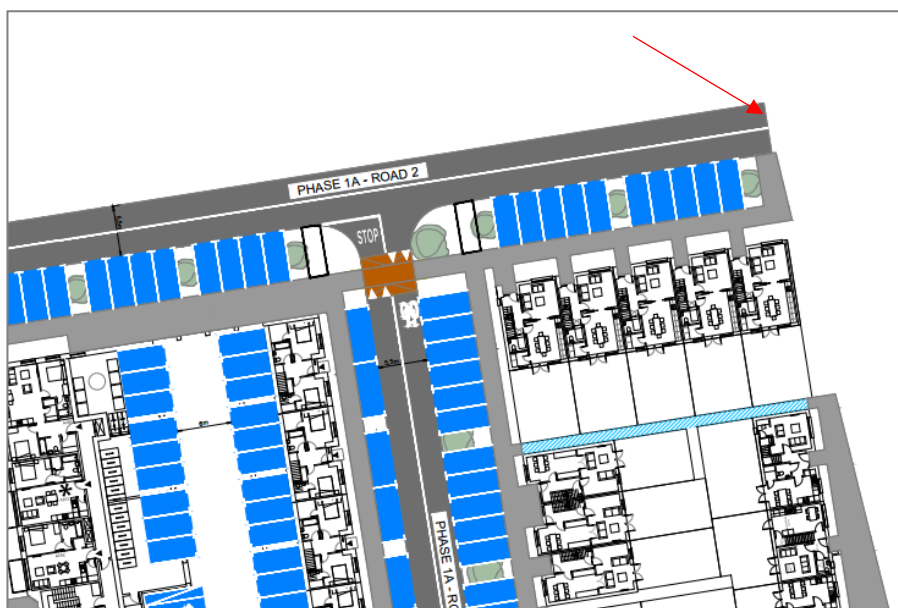
Figure 2-6 – Example stopped end

This could result in multi-point turning or reversing manoeuvres by vehicles attempting to turn around, increasing the likelihood of collision with other road users.

#### Recommendation:

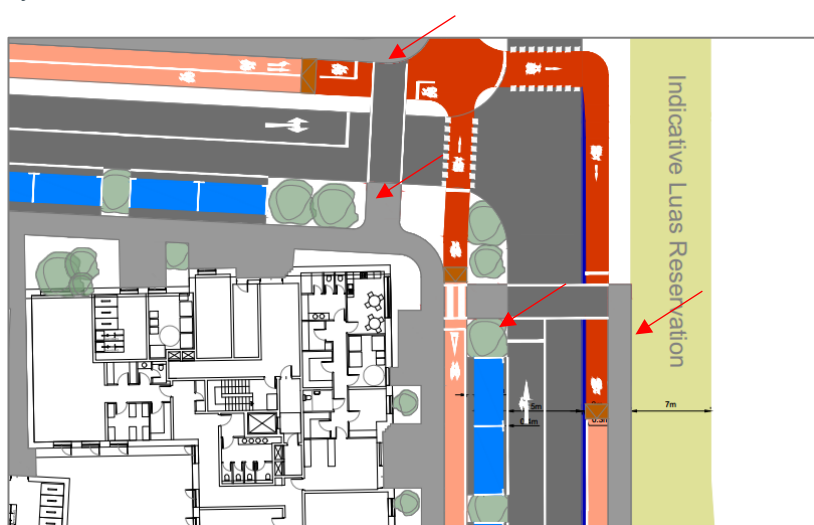
Figure 2-7 – Example of lack of provisions for Visually Impaired Pedestrians

#### Location: Old Connaught Development Throughout

There are no tactile paving provisions on footpaths throughout the development, which could lead to confusion for visually impaired pedestrians along the scheme. This could result in pedestrians coming into conflict with cyclists and motorists.

### Recommendation:

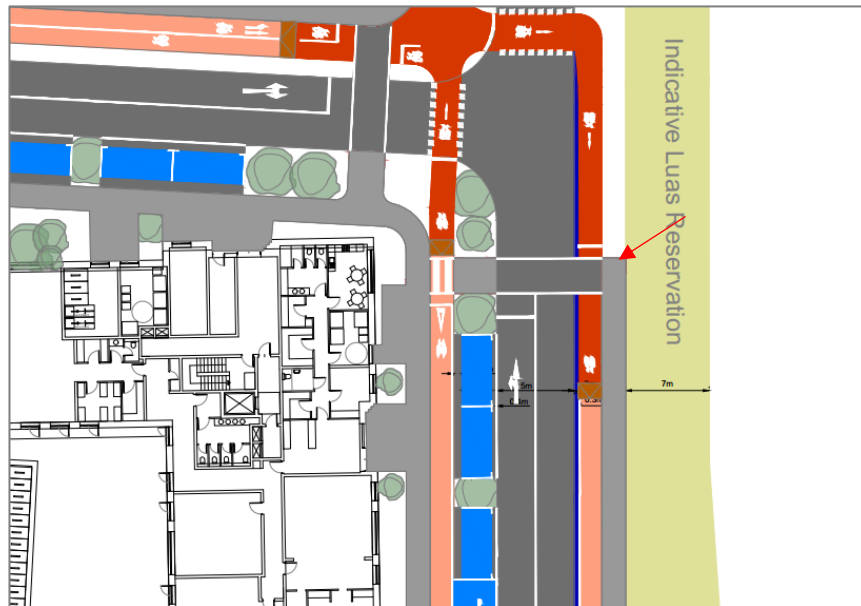
**Figure 2-8 – Abrupt End to Footpath**

**Location:** Old Connaught Development NS Road Northern End

The eastern footpath at the northern end of NS Road ends abruptly with no indications for further pedestrian movement. This could result in pedestrian confusion, especially visually impaired users, resulting in potential conflict between pedestrians and cyclists/vehicles.

### Recommendation:

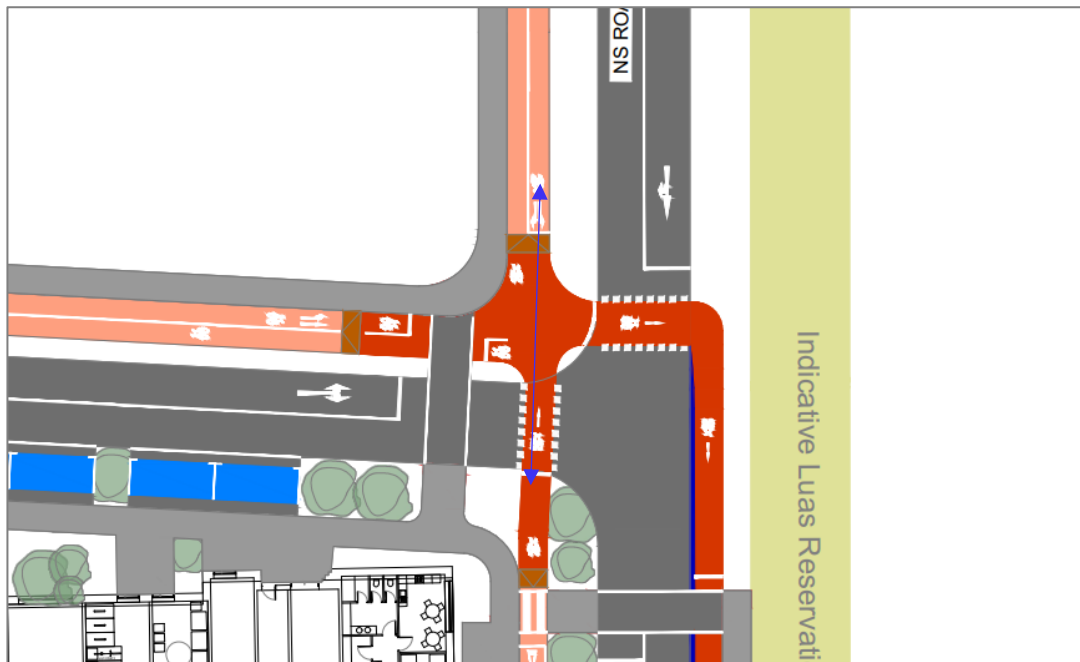
**Figure 2-9 – Cycle Path Alignment**

**Location:** Old Connaught Development NS Road Cycle Path Northern End

The northbound cycle path at the northern end of NS Road is aligned in a manner that could result in cyclists moving northward (after crossing EW road) coming into conflict with cyclists traveling southbound along the cycle path at the northern end of NS Road, and vice versa.

**Recommendation:**

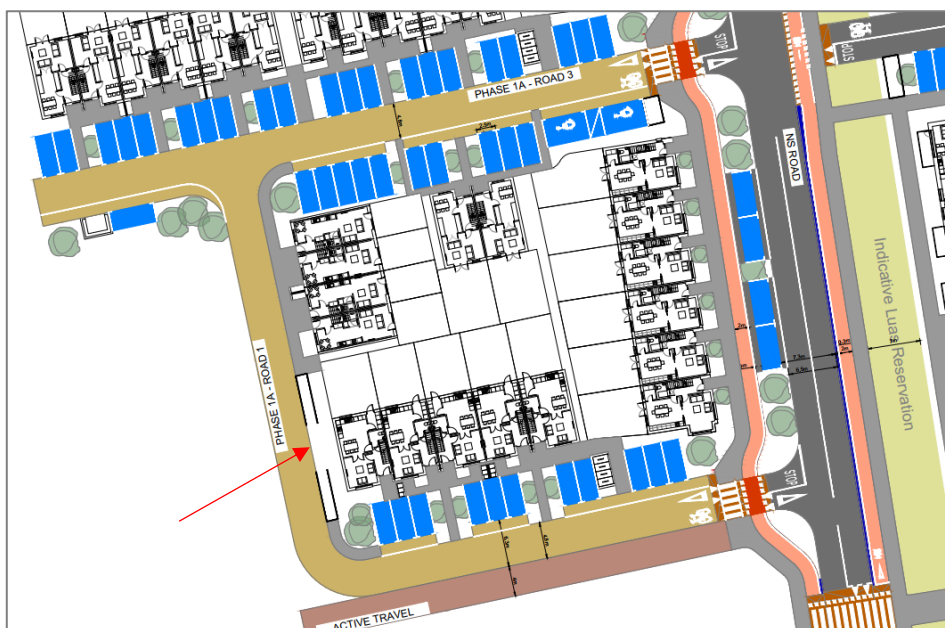
**Figure 2-10 –Pedestrian Provisions in Western Homezone**

**Location: Western Homezone**

There is a lack of consistency between streets within the western Homezone (i.e. the white line indicating a pedestrian area is not shown along the western leg of Road 1. This could cause confusion as drivers may not be able to anticipate where pedestrians would be, increasing chance of collisions.

**Recommendation:**

| To be completed by the Designer | | | | To be completed by the Audit Team |
|---|---|---|---|---|
| 2.10 | Yes | No | <ul style="list-style-type: none"> <li>The carriageway surface within the Home Zone street will be differentiated through the use of contrasting materials, texture, and colour in accordance with Section 4.4.2 of DMURS, thereby distinguishing it from other street typologies.</li> <li>The carriageway width is 4.8 m, which is the minimum recommended width for a Home Zone street as set out in Section 4.4.1 of DMURS. The reduced carriageway width contributes to lower vehicle speeds and improved pedestrian priority.</li> <li>Shared Street Symbol Markings (M133), in accordance with Chapter 7 of the Traffic Signs Manual, will be provided along the Home Zone street. The markings will be installed at the commencement of the Shared Street and repeated after each junction. Where spacing between junctions exceeds 100 m, additional markings will be provided at intervals of 50–100 m.</li> </ul> | Yes |

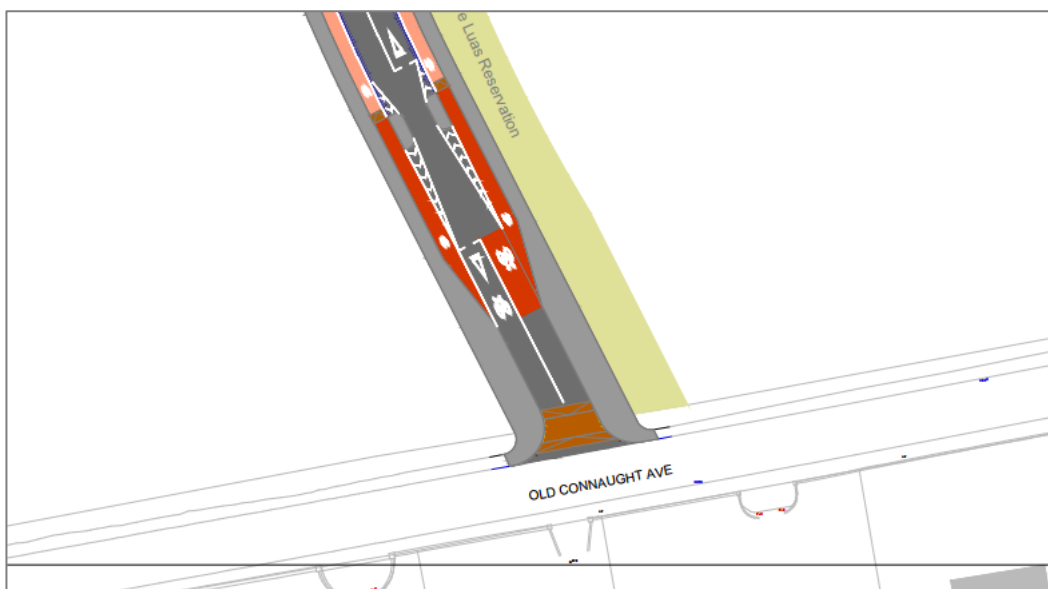
**Figure 2-11 – Road Markings for the NS Road / Old Connaught Avenue**

**Location: NS Road / Old Connaught Avenue Junction**

Road markings for the NS Road / Old Connaught Avenue are not indicated. This results in uncertainty about pedestrian/vehicular priority at the junction. There is no indication that vehicles should Stop for Old Connaught Avenue traffic, which could result in collisions.

**Recommendation:**

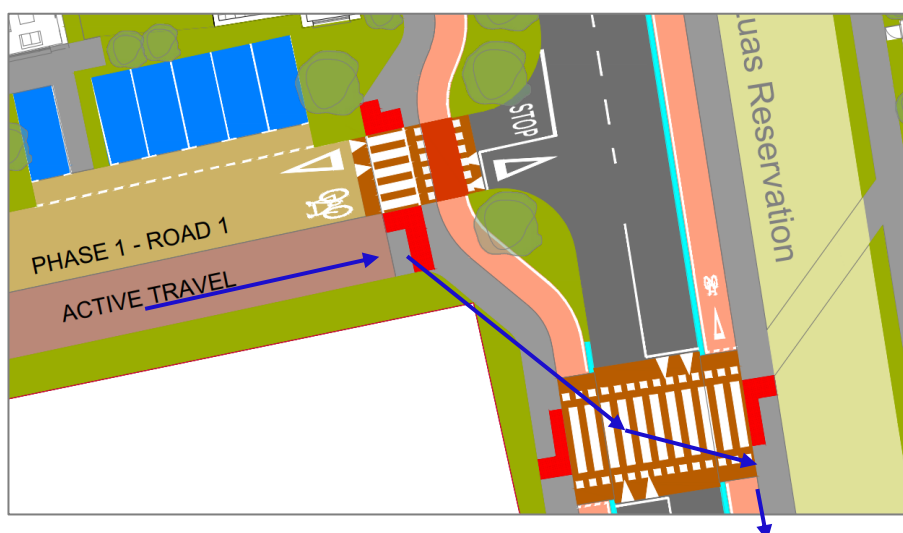
**Figure 2-12 – Cyclist Access to Crossing**

**Location: NS Link Street / Phase A1 Road 1 Southern Link**

The current layout of the NS Link Street / Phase A1 Road 1 Southern Link junction requires cyclists traveling along the active travel area to traverse pedestrian and oncoming cyclist facilities in order to cross NS Link Street to access the southbound cycle lane along NS Link Street. Additionally, northbound cyclists wishing to turn left into or out of the active travel area have no provision. This could result in collisions between cyclists and pedestrians/other cyclists.

### Recommendation:

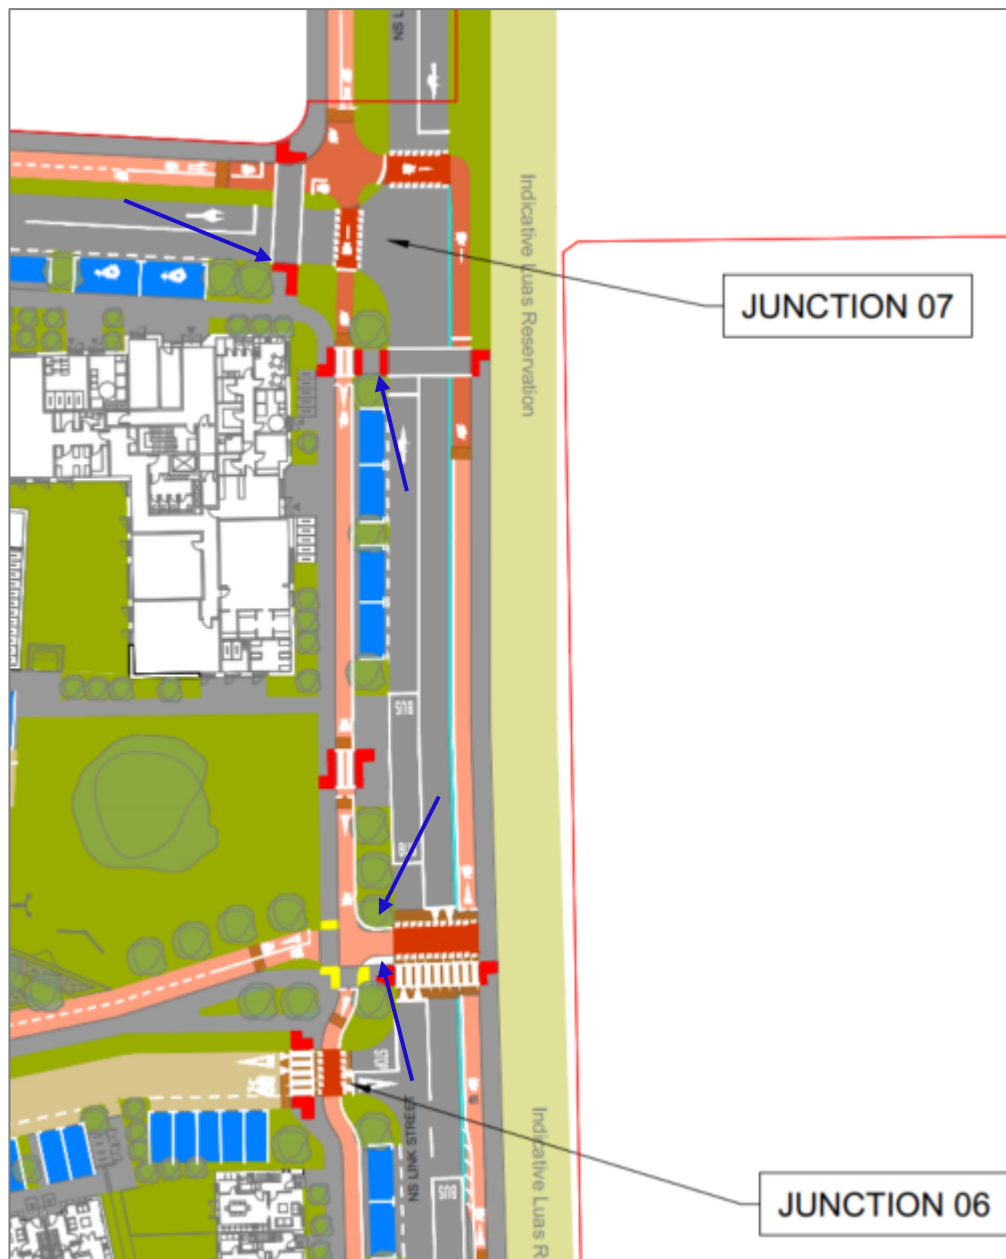
Figure 2-13 – Visibility of Signal Heads at Crossings

### Location: Junction 7 & Junction 6 Crossings

The current tree provisions at the EW Link Street / NS Link Street Crossing as well as the Phase A1 – Road A / NS Link Street Crossing could potentially restrict the visibility of motorists along EW Link Street and NS Link Street to observe the crossing signal heads at both crossings. This could result in motorist/pedestrian collisions.

### Recommendation:

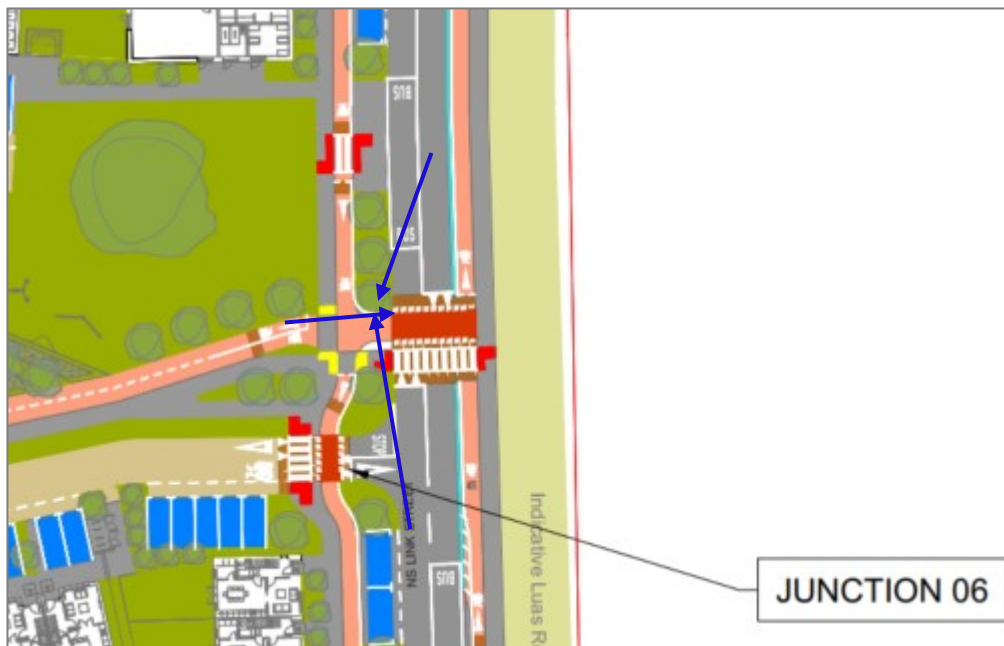
Figure 2-14 – Visibility of Pedestrians/Cyclists at Crossing

### Location: Junction 6 Crossing

The current tree provisions at the Phase A1 – Road A / NS Link Street Crossing could potentially restrict the visibility of motorists along NS Link Street to observe cyclists and pedestrians approaching the crossing. This could result in motorist/pedestrian collisions.

### Recommendation:

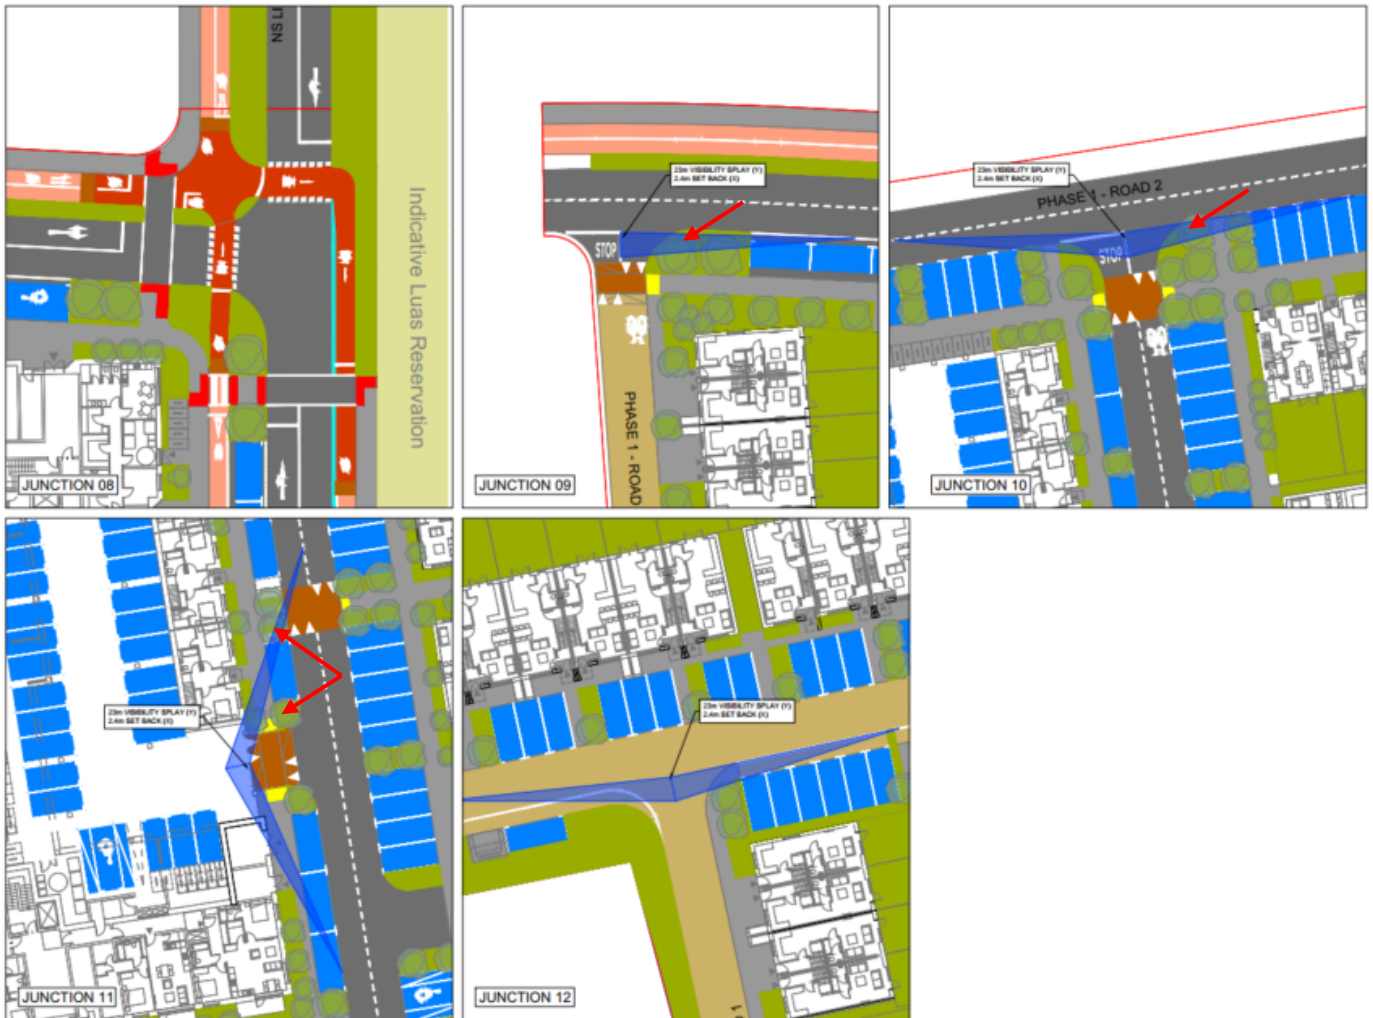
**Figure 2-15 – Trees Restricting Visibility Splays**

### Location: Junctions 3, 5, 6, 9, 10, 11

The current tree provisions at the junctions 3, 5, 6, 9, 10 and 11 restrict the y-distance visibility splays of motorists exiting the junctions. This could result in vehicle collisions.

**Recommendation:**
